# NSEA 2023 Monitoring Report

The Nooksack Salmon Enhancement Association (NSEA) performs implementation and effectiveness monitoring to evaluate project success and improve future projects. We monitor the survival of our trees and shrubs at planting sites, fish presence at instream project sites, temperature at select sites, and complete habitat assessments at instream restoration sites.

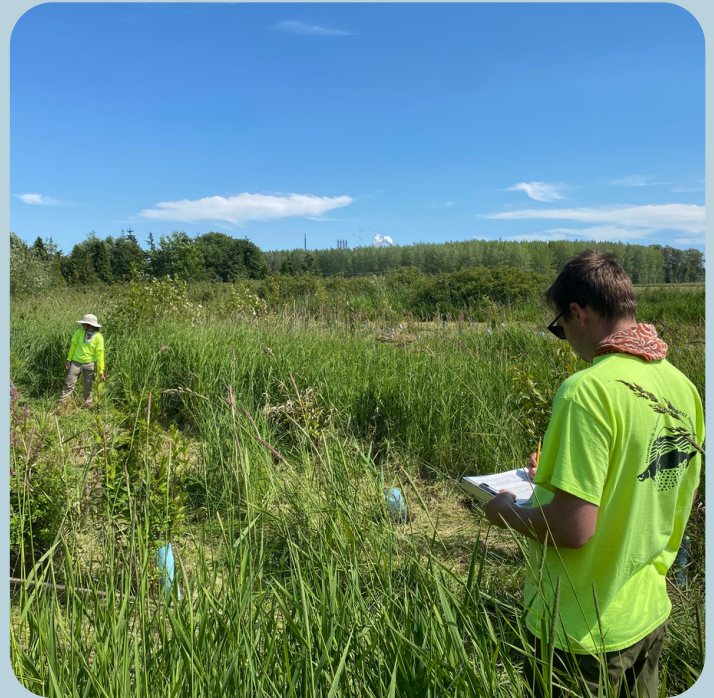
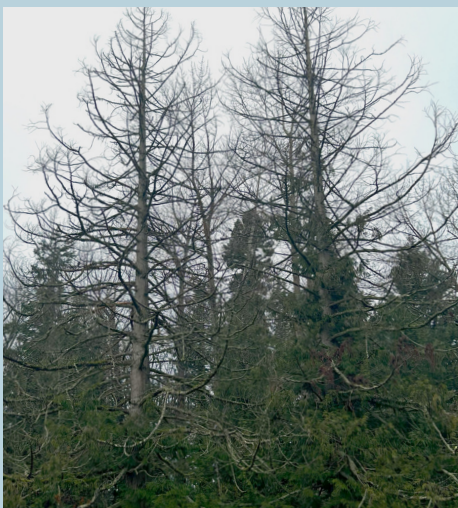
Western red cedar dieback on  
NSEA Campus

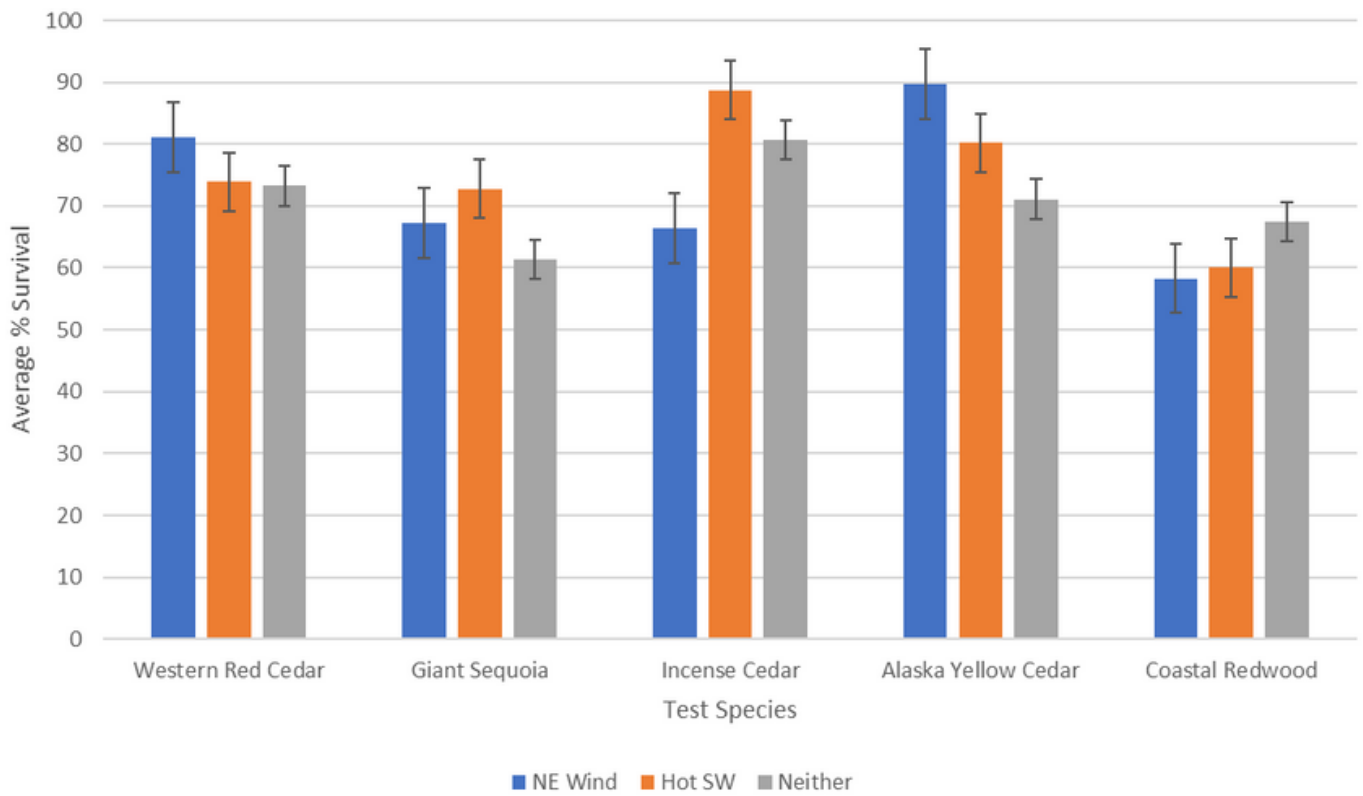
## Fall 2023 Overall Survival of Conifer Test Species

The above table summarizes the results from the Fall 2023 monitoring. These results show that at sites with NE wind exposure, Alaska yellow cedars are outperforming other species. We also observed that incense cedar has a higher survival percent than other species in both of the other treatments.

Test species were planted with three different treatments – northeast wind (NE Wind), hot southwest exposure (Hot SW), or neither. The results from Fall 2023 are shown on the next page. It is too soon to draw conclusions that would alter our adaptive management protocols, but we intend to perform a larger analysis of our data in 2024 which is the halfway point of our 10 year study.

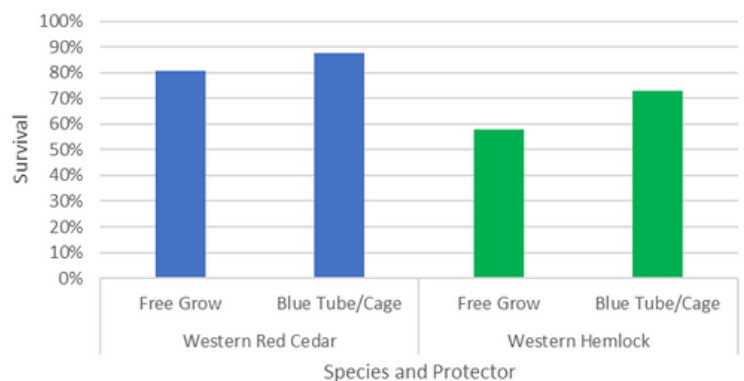
### Survival of Two Species with Protector Type

In 2021 NSEA started installing five feet tall Khowutzun Freegro TreeShelters (KFT) to test their effectiveness compared to the other browse protectors we typically use. Since then we have monitored survival of western red cedars and western hemlocks with KFT shelters and blue tube/cage protection. The data shows that survival is lower using KFT shelters, we think that this is due to site conditions like flooding and wind in combination with sizing issues in our stock of wooden stakes. As such we will not be assessing effectiveness of KFT shelters outside of normal monitoring protocols until we can procure correctly sized materials.

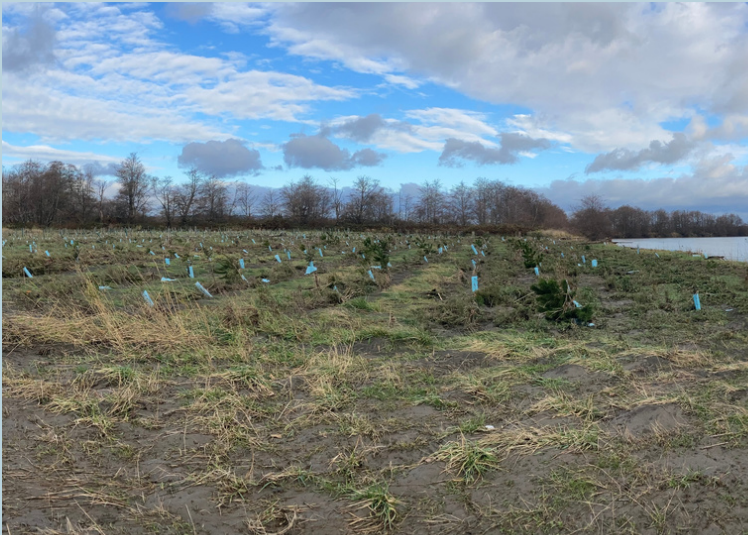
Nooksack River (2022) - From Ground

NSEA documents the progression of plant growth and other changes at some sites by creating photo points with a drone. We are experimenting with a drone to collect photos more efficiently and accurately. Our goal is to continue drone research and training in 2024 to improve the data collection process and create a replicable and efficient protocol.

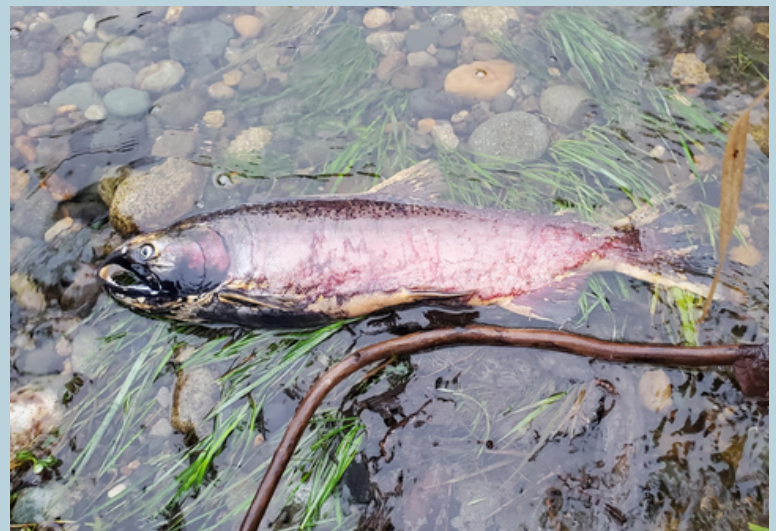
Coho found in a California Creek tributary in 2023

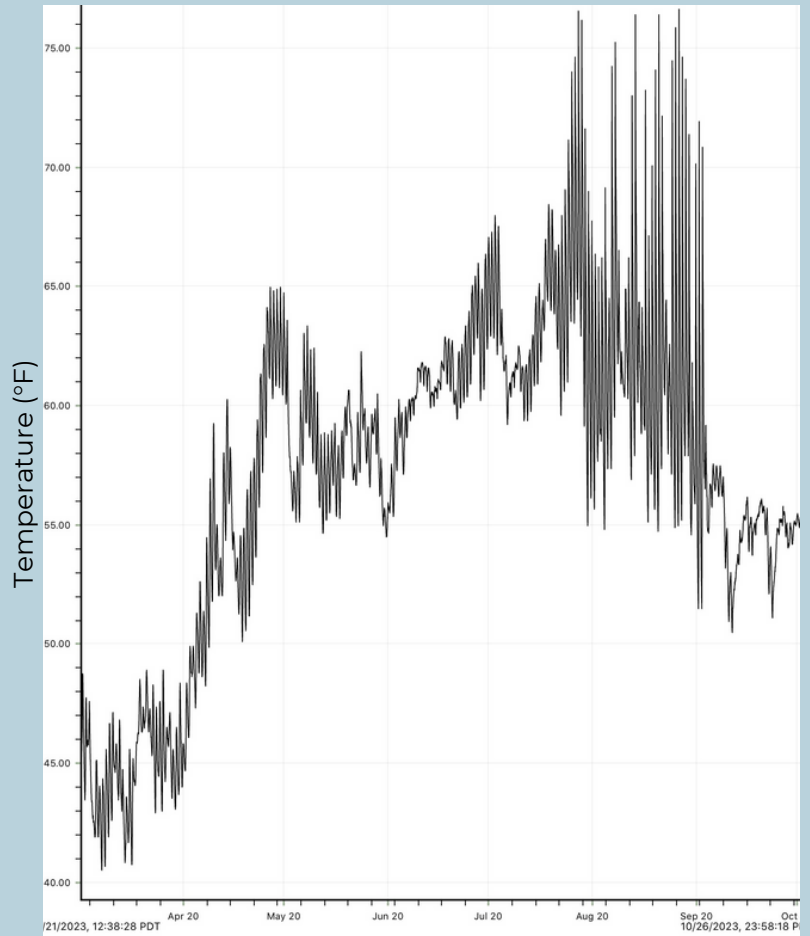
Squalicum Creek Temperature Graph

Salmon need cold water to survive, especially in summer months when there are warmer temperatures and less rainfall. Water temperatures over 20°C (68°F) contain less dissolved oxygen and suffocate salmon. Riparian plantings provide shade that keeps streams cooler during summer and decrease salmonid fatality. In 2018, NSEA installed four water temperature loggers in a Squalicum Creek project reach in the Dewey Valley. In 2021 we installed 2 temperature loggers at a Tenmile Creek project site. The graph on the right is an example of our data from one of our Squalicum Creek loggers. All loggers in Squalicum Creek recorded temperatures above 68°F during summer of 2023. These loggers will monitor water temperatures for a minimum of 10 years and will hopefully show summer water temperatures decreasing over time as conditions in the watershed hopefully continue to improve.

April 2023 - October 2023

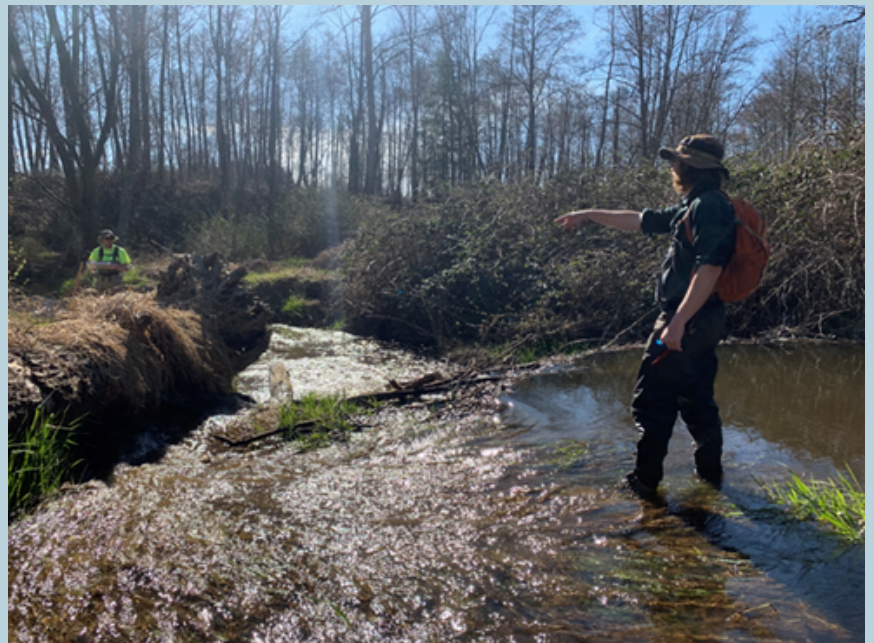
# Habitat Assessments

NSEA prioritizes restoration goals and objectives, which is why we annually perform instream habitat assessments to determine whether we are meeting our standards. For three to five years after a project is completed, the restoration crew collects data on pool depth, width and length, and available spawning gravels. We also document the presence of LWD and invasive vegetation. In 2023, NSEA completed 6 assessments over 2.7 miles of stream. This includes one Terrell Creek site that is over 2 miles long. It will take many years to observe how the instream habitat changes over time at this site where 200 pieces of LWD were installed. The NSEA crew will continue to assess this site for at least two more years, depending on funding, but it is too soon to draw any conclusions.
